AIRCRAFT ACCIDENT
N800X (342)
25 FEB 1966

AIRCRAFT ACCIDENT INVESTIGATION N800X (342)

AIRCRAFT ACCIDENT ARTICLE 342 (N800X)

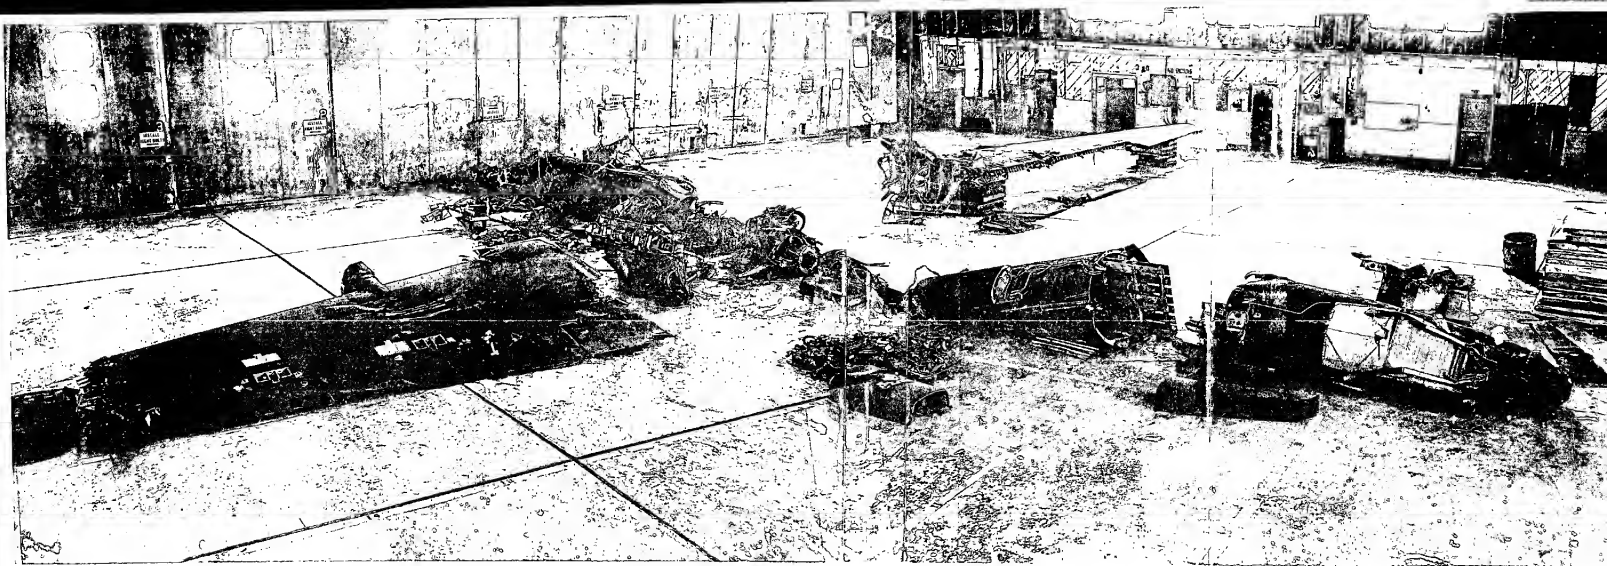
GENERAL VIEW OF COMPONENTS OF NS800X (342) RECOVERED FROM THE FIELD.
THE FORWARD FUSELAGE, AFT FUSELAGE AND TAIL SURFACES WERE PARTLY
DISMANTLED FOR TRANSPORTATION PURPOSES AS WAS THE RIGHT WING FLAP.
THE LEFT WING OUTER SECTION WAS BROKEN WHEN DROPPED FROM HELICOPTER.

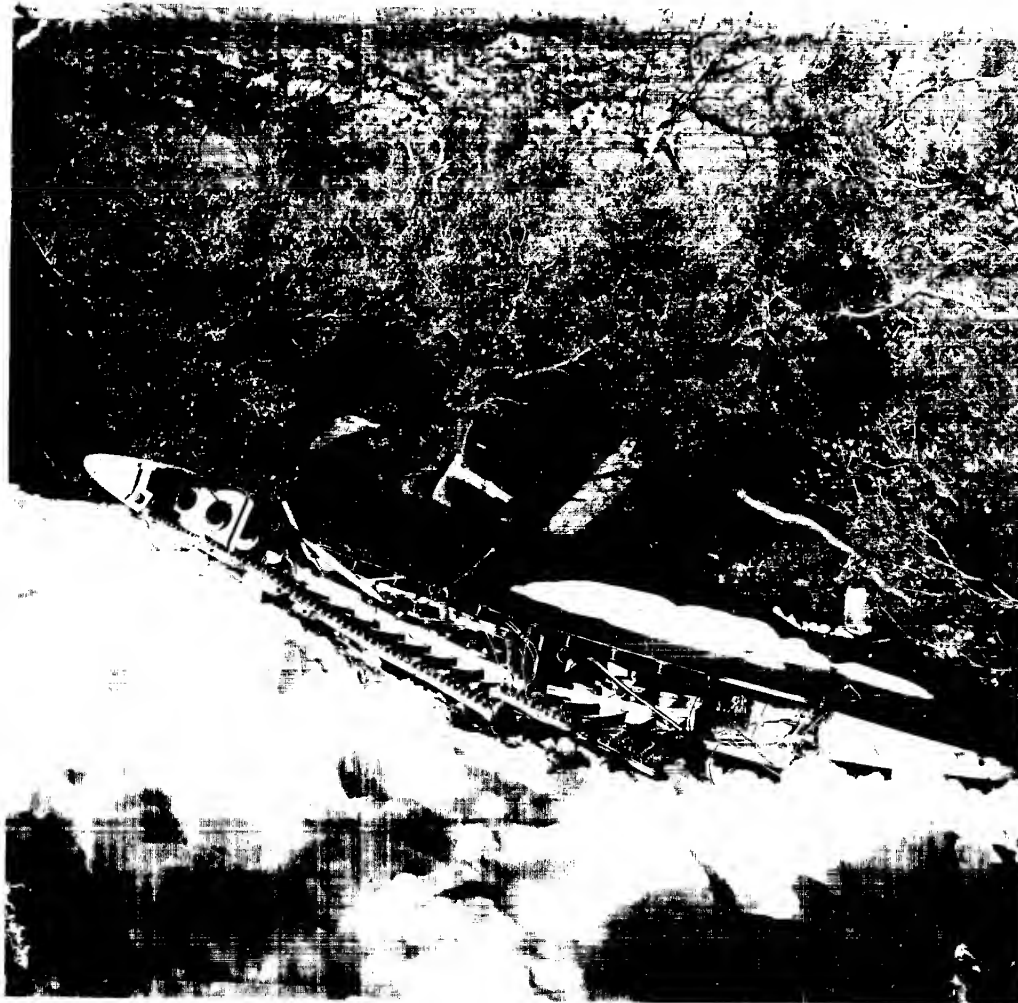
4. The left wing failed at the root at the same time as aileron was being applied, (left aileron down). This application of aileron, at the same time as positive "G" was being exerted, applied a twisting moment to the wing at the same time as it was subjected to a bending moment at a high airspeed. The design characteristics of the wing are such that there is an aerodynamic tendency for it to twist leading edge up about the flexural axis. Downgoing aileron exerted an opposing twist and the resultant effect was that an additional up load was placed on the outer wing causing it to bend upwards and thus produce a levering moment about the root attachment which was the area of the initial structural failure.

LEFT WING IN THE FIELD (UPSIDE DOWN) SHOWING THE
PRIMARY STRUCTURAL FAILURE POINT AT THE WING ROOT.

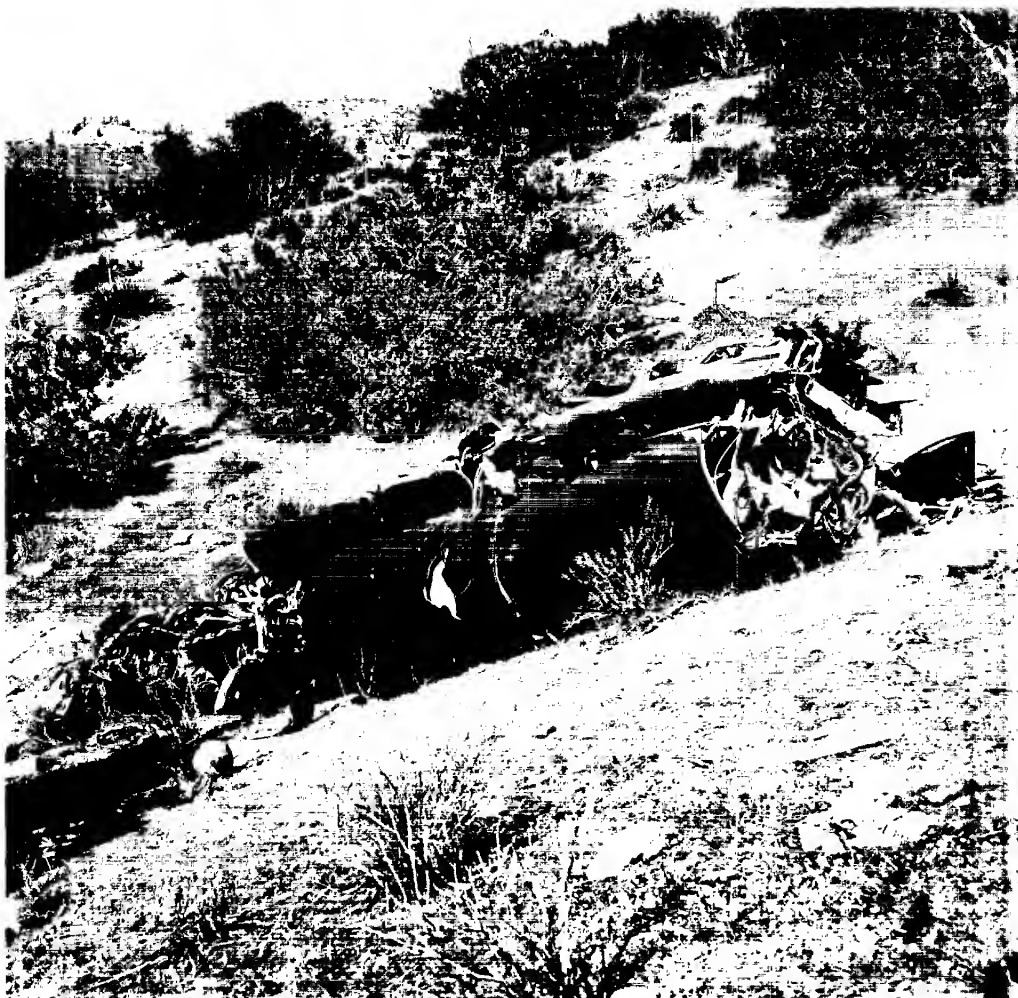
FORWARD FUSELAGE IN THE FIELD. LANDED ON THE RIGHT SIDE.
ALMOST FLAT, BOUNCED OVER ONTO THE LEFT SIDE.
